INDIAN RUN DAM

PHASE I INSPECTION REPORT NATIONAL DAM INSPECTION PROGRAM

JULY 1978

INDIAN RUN DAM
SCHUYLKILL COUNTY, PENNSYLVANIA
NATIONAL I.D. NO. PA 00696

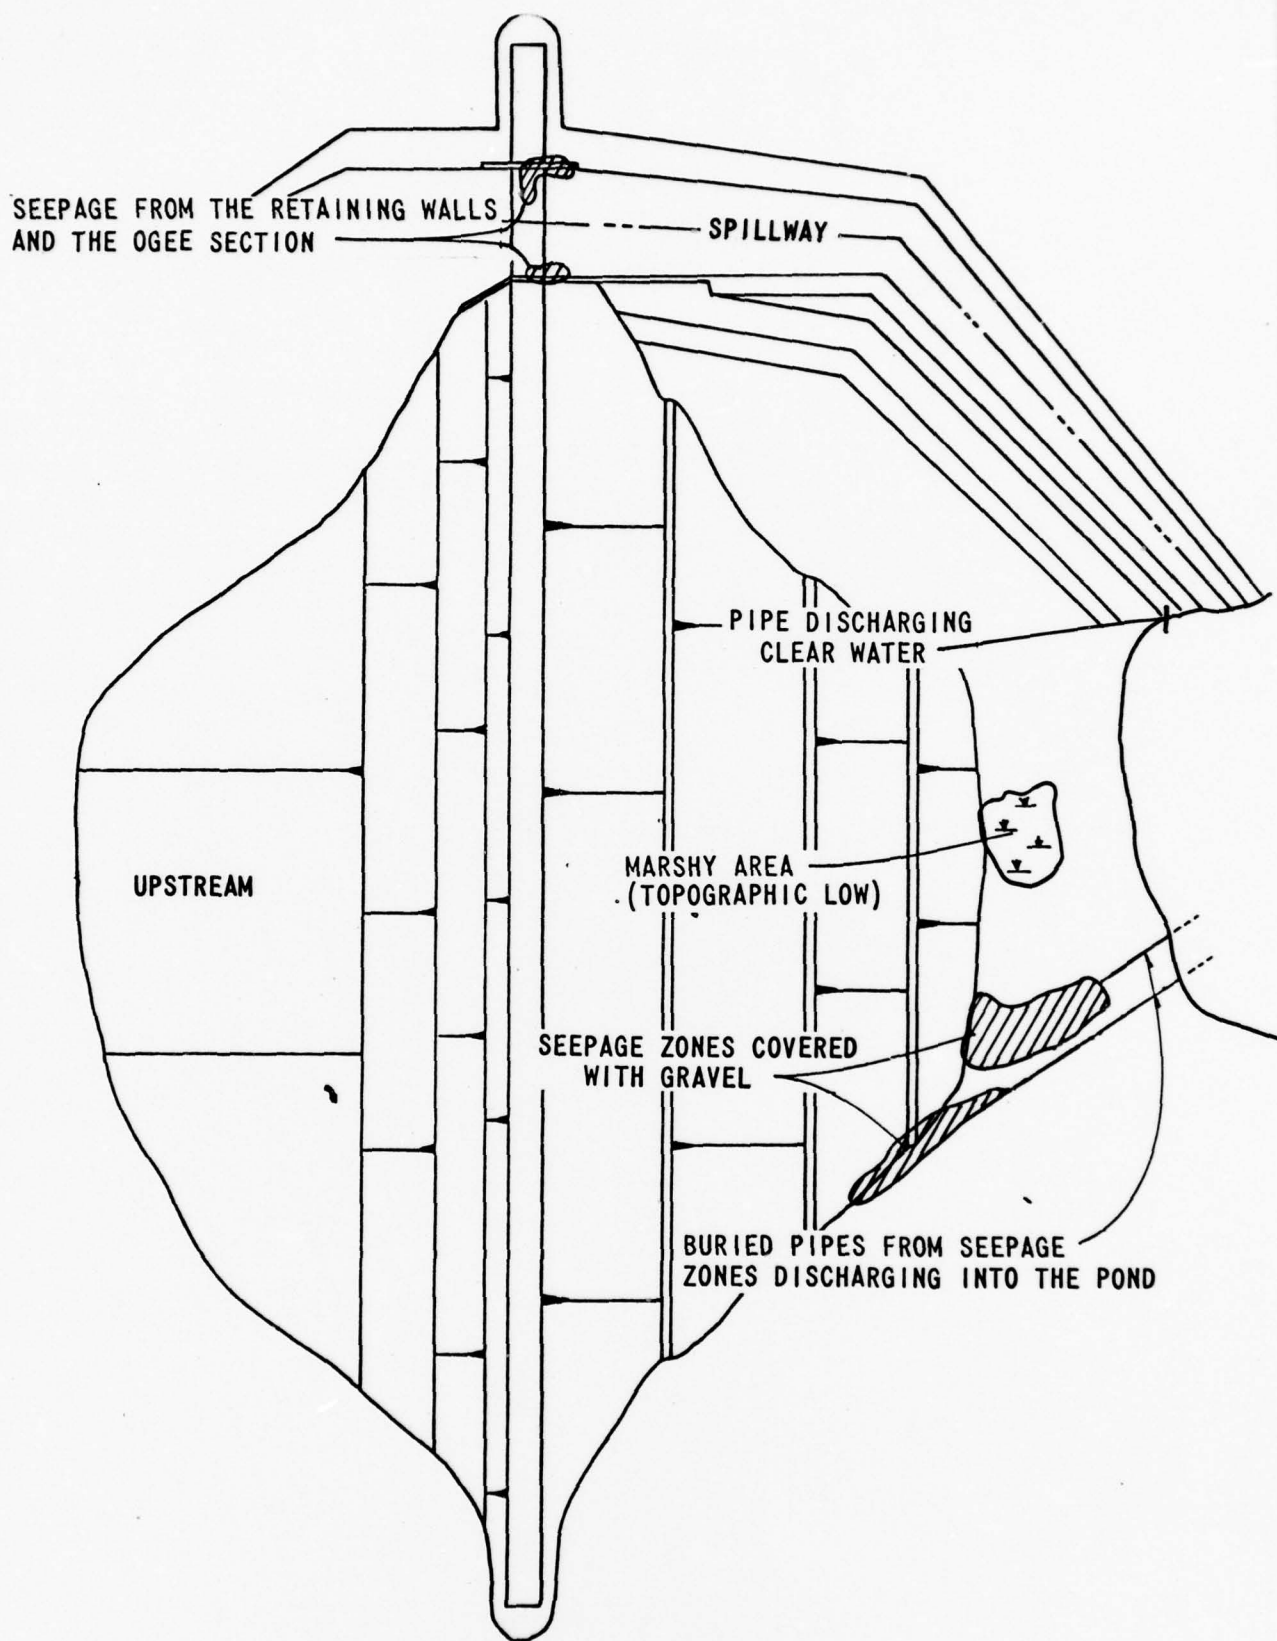
SEEPAGE LOCATION PLAN
INDIAN RUN DAM
SHEET 5a OF 11

Three drain pipes were noted as shown on sheet 5a.

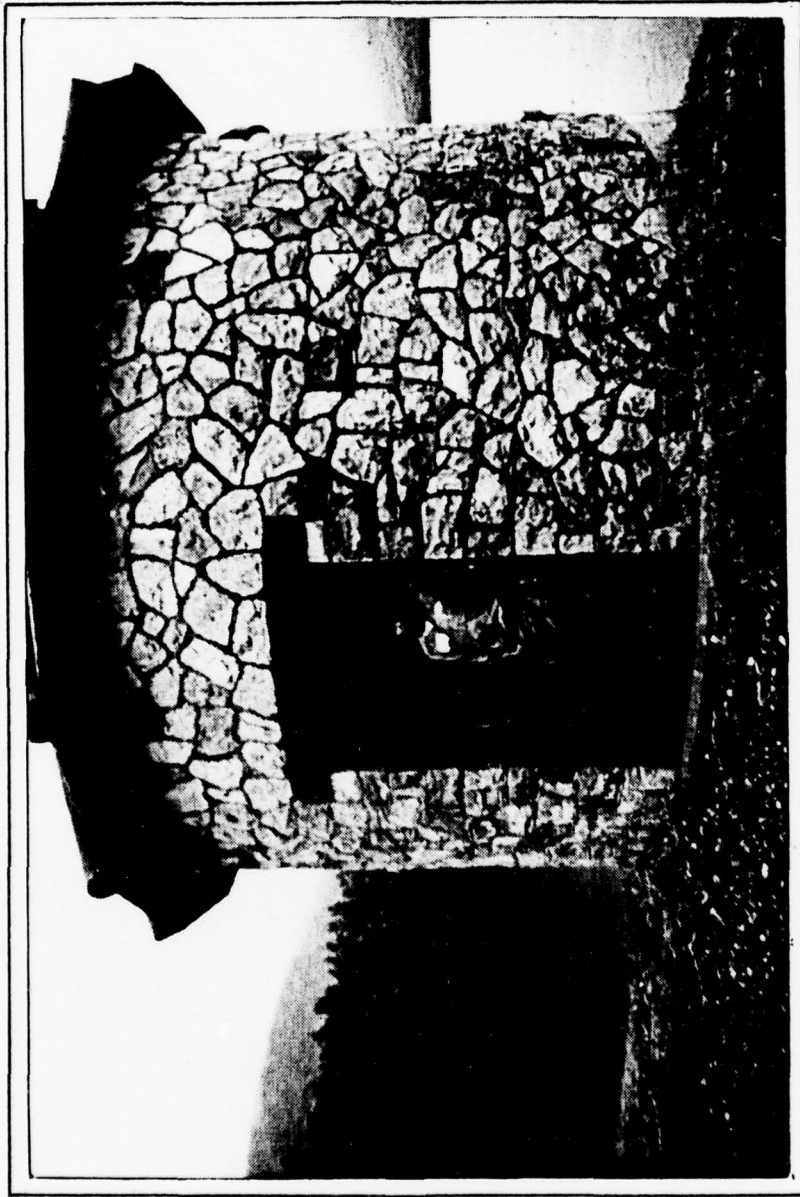
PHOTOGRAPH NO. 1

INTAKE TOWER LOCATED AT TOP OF SLOPE
ON UPSTREAM SIDE.

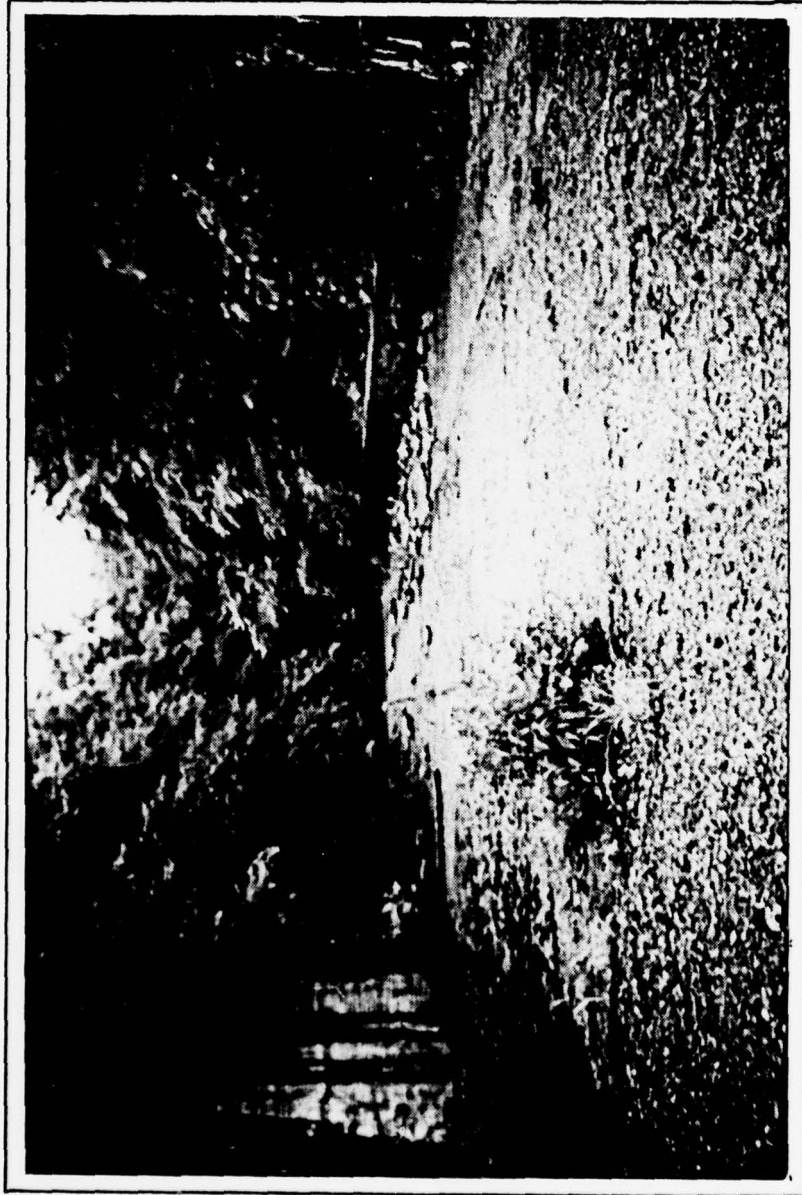
PHOTOGRAPH NO. 3

VIEW LOOKING DOWNSTREAM OF PRINCIPAL
SPILLWAY FROM OVERFLOW WEIR. NOTE
SPALLING CONCRETE.

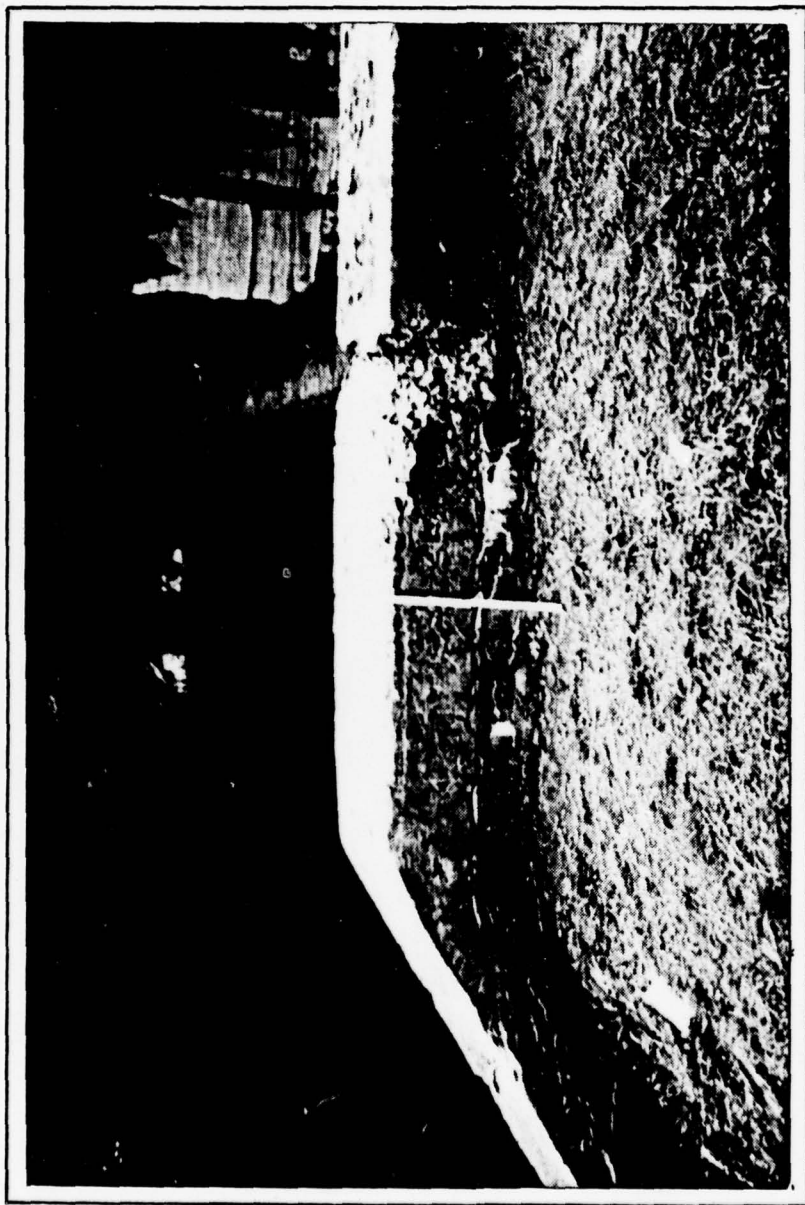
PHOTOGRAPH NO. 7

SPALLED CONCRETE OF SPILLWAY WALLS.
NOTE SETTLEMENT OF EMBANKMENT ADJACENT
TO WING WALLS.

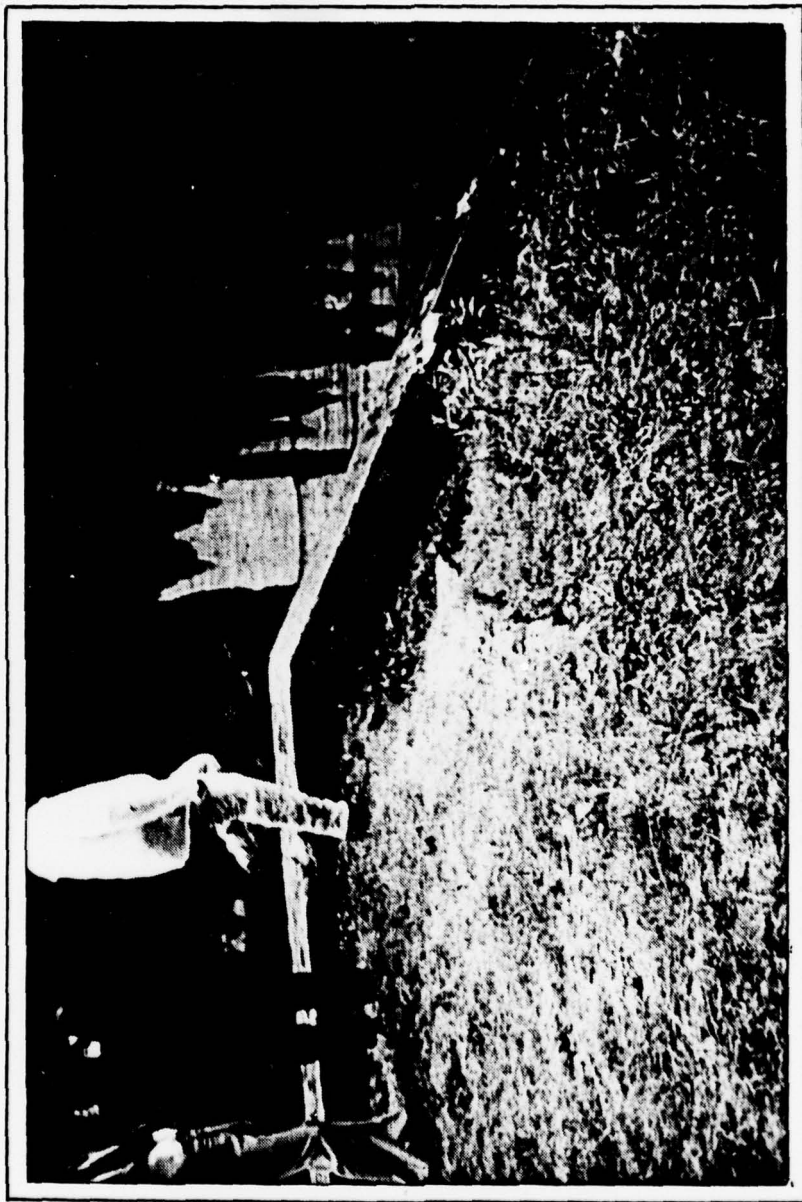
As shown on Photograph No. 8, erosion and settlement of the embankment was noted adjacent to the spillway wall. This settlement feathered out about 40 feet from the wall. This settlement has lowered the embankment crest by at least 9 inches and, correspondingly, reduces the flood storage capacity.

PRINCIPAL SPILLWAY. NOTE CONCRETE
DETERIORATION AND EROSION ADJACENT
TO WING WALLS. DESIGN CALLED FOR
FILL TO TOP OF WALLS.

Some erosion was noted at the junction between the embankment and the emergency spillway. This erosion has effectively reduced the crest height of the dam by approximately one foot. The crest should be restored to the design elevation.

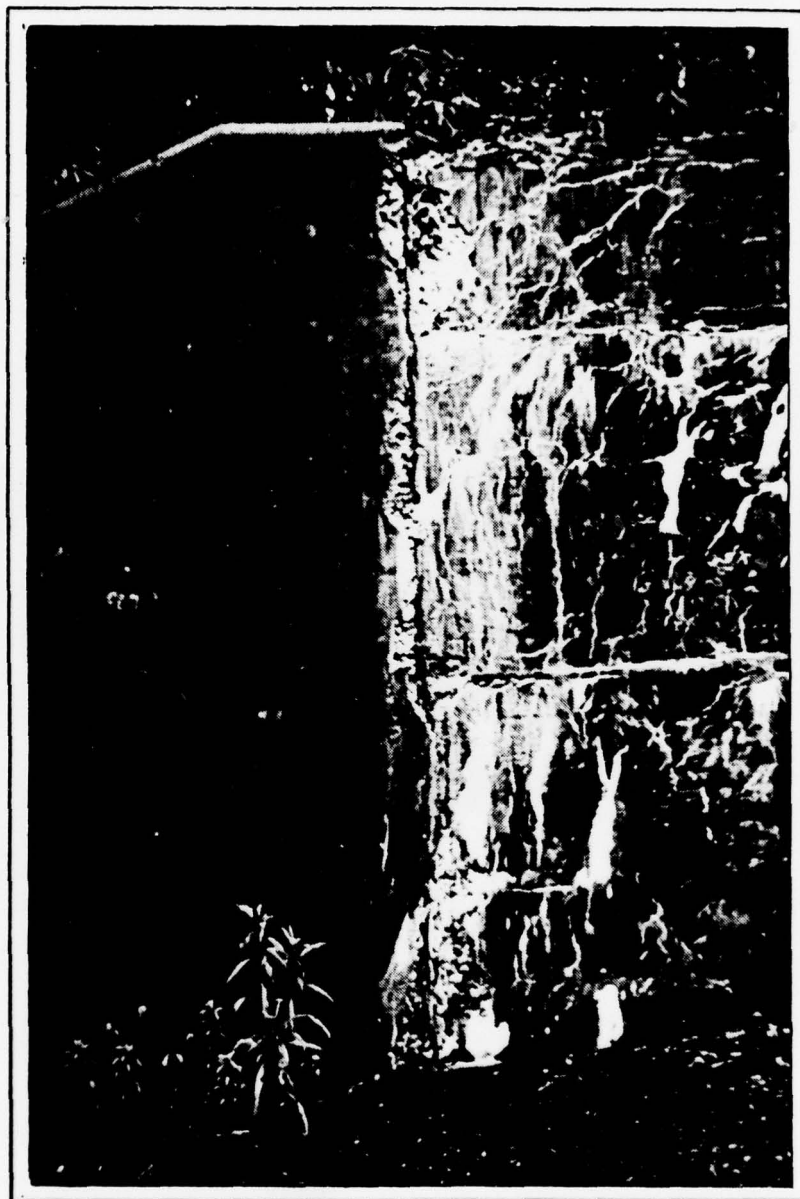
PHOTOGRAPH NO. 9

DETERIORATED RIGHT WALL
OF PRINCIPAL SPILLWAY.

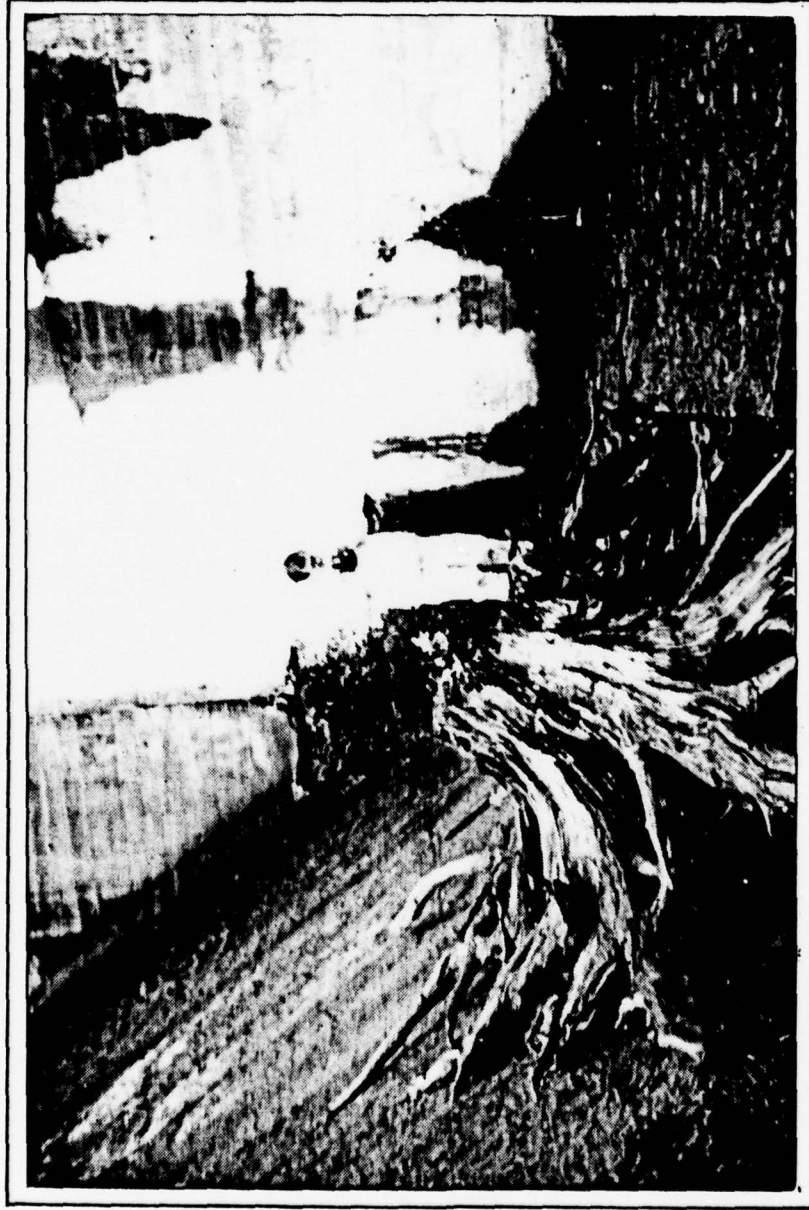
PHOTOGRAPH NO. 10

PRINCIPAL SPILLWAY. NOTE DETERIORATION ON LEFT WALL, SEEPAGE THROUGH WALL AND DEBRIS IN CHANNEL. SEEPAGE THROUGH SPILLWAY AND PORTIONS OF THE WALL FLOWS UNDER SLAB AT THE CONSTRUCTION JOINT.

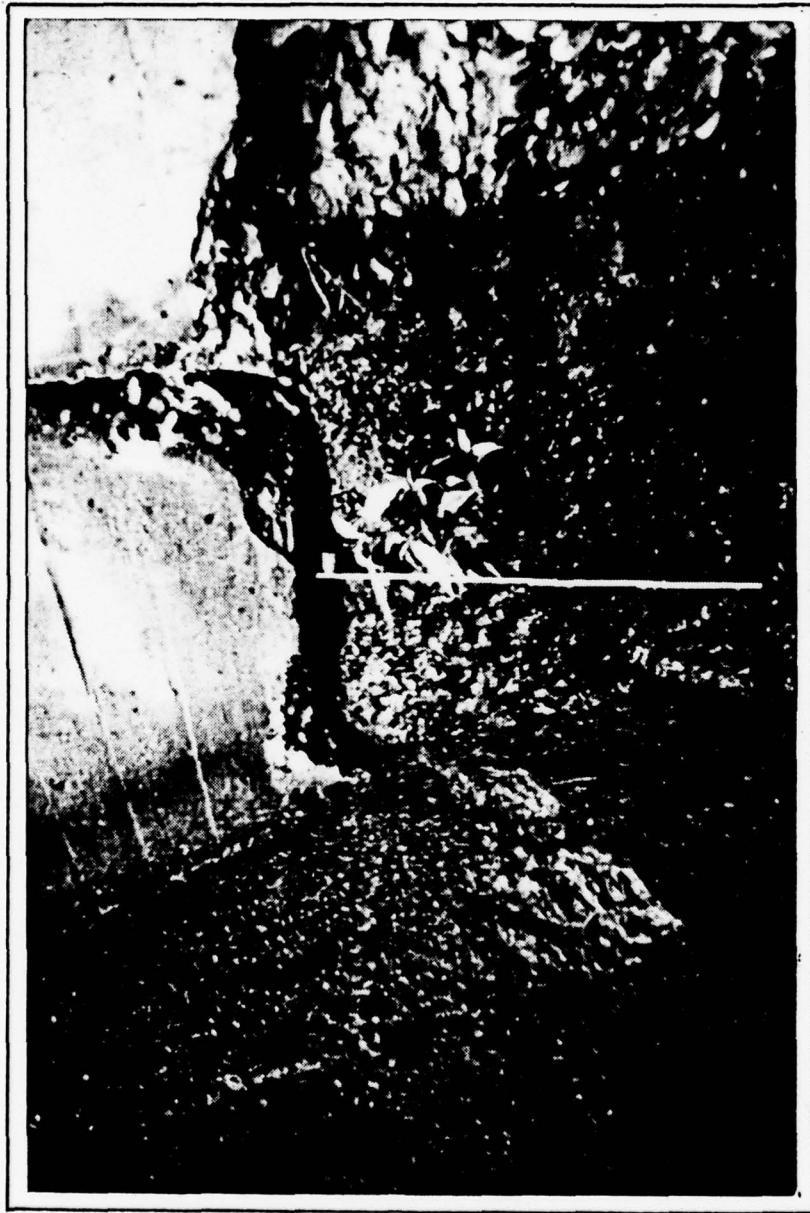
PHOTOGRAPH NO. 11

CLOSE-UP VIEW OF LEFT SPILLWAY WALL
DETERIORATION.

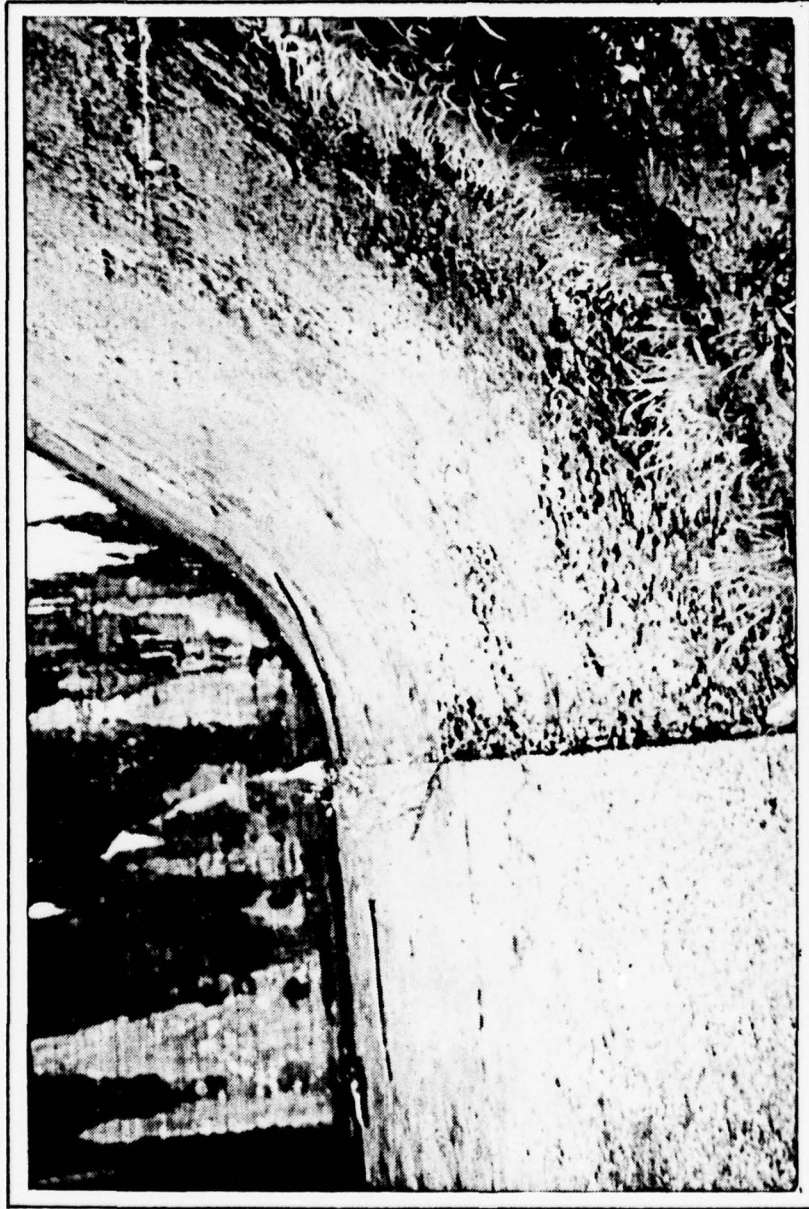
PHOTOGRAPH NO. 12

VIEW OF CONSTRUCTION JOINT AT BASE
OF OGEE SPILLWAY WHERE SEEPAGE ENTERS
AND FLOWS UNDER THE SLAB.

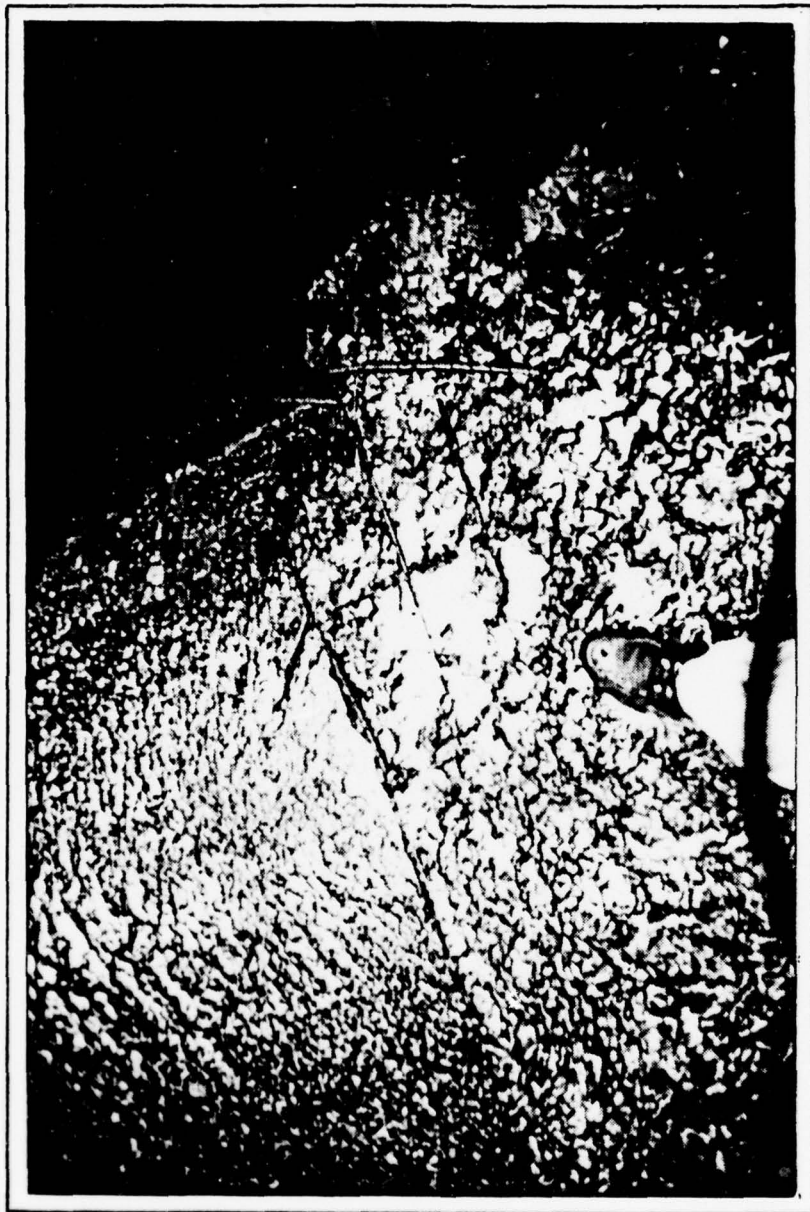
PHOTOGRAPH NO. 13

VIEW OF DETERIORATED CONCRETE ALONG
CHUTE SPILLWAY. NOTE EXPOSED AND
RUSTED REINFORCING STEEL.

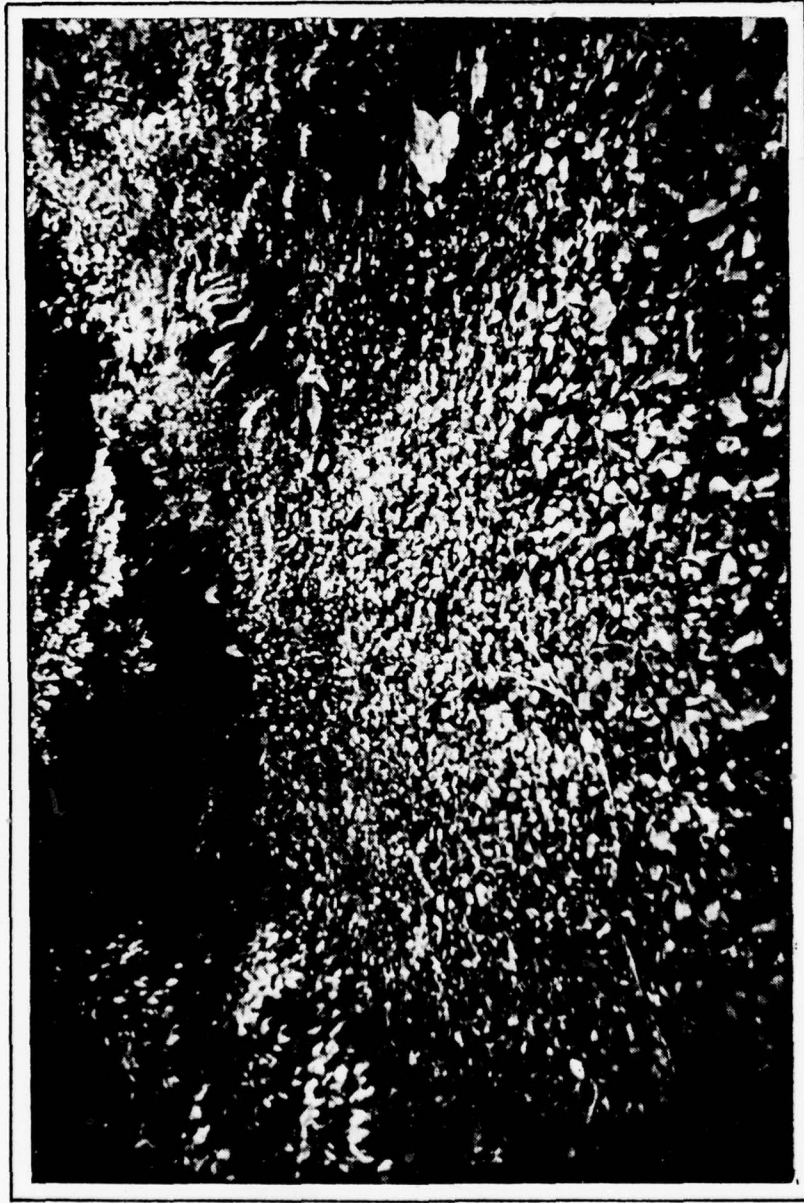
TYPICAL SEEPAGE AREA ON RIGHT SIDE OF
DAM (DOWNSTREAM SLOPE) WHICH WAS EX-
CAVATED AND REPLACED WITH GRAVEL. PIPES
LEAD FROM THE GRAVEL INTO THE LOWER
POND.
